# Manhole Inspection Summary

Manhole # S01UU1023MH

Insp Date: **8/11/06 12:00 AM**

**Location** Address: **3702 MENLO DR**

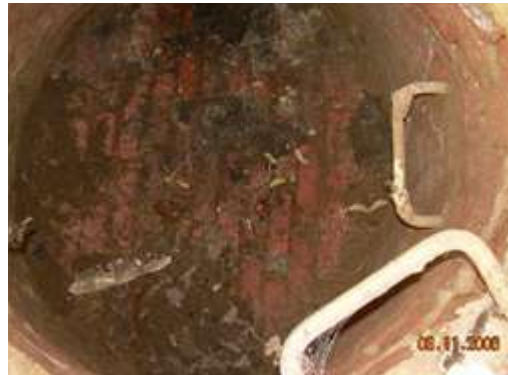
Top View

Corbel deterioration and infiltration. Barrel infiltration. Channel debris.

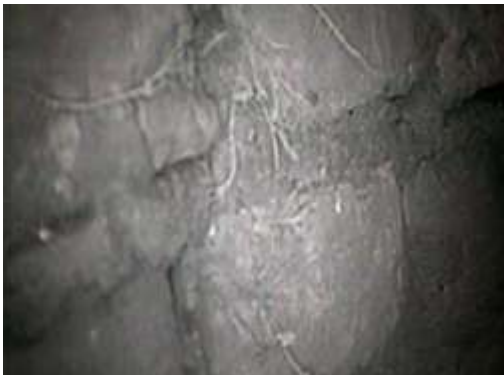
Defect

Barrel root intrusion and infiltration.

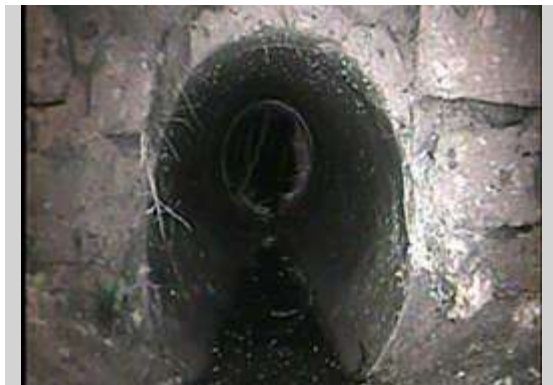
Pipe Out @ 12 O'Clock

Pipe Seal Cond: **Roots**
